Student Water Monitoring on Bayou St. John during Control Structure Removal

Wm. A. Pestoff, BS and Andrea Bourgeois-Calvin, PhD, Lake Pontchartrain Basin Foundation
Kathryn Langley, University of New Orleans Graduate Student
John O'Donnell and Chien-Hsiu Weng, Tulane University Graduate Students

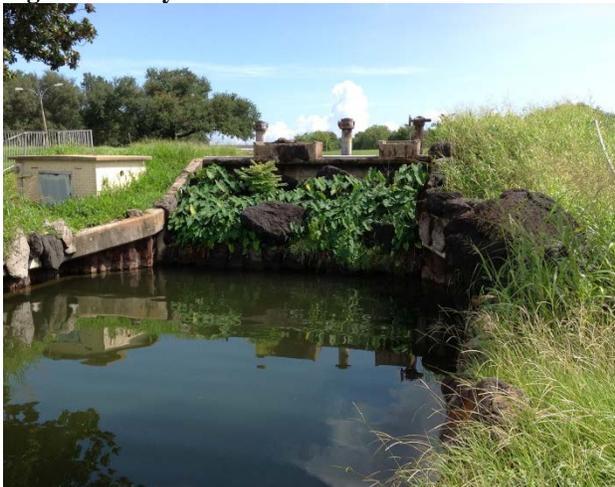
Figure 1a. Bayou St. John Control Structure

In late 2012, the old water control structure at Robert E. Lee Dr. was removed. The Lake Pontchartrain Basin Foundation (LPBF) performed water quality monitoring prior to, during, and following the removal of the structure at sites along the length of Bayou St. John to measure any changes to water quality as a result of removing the structure (Figures 1a and 1b).

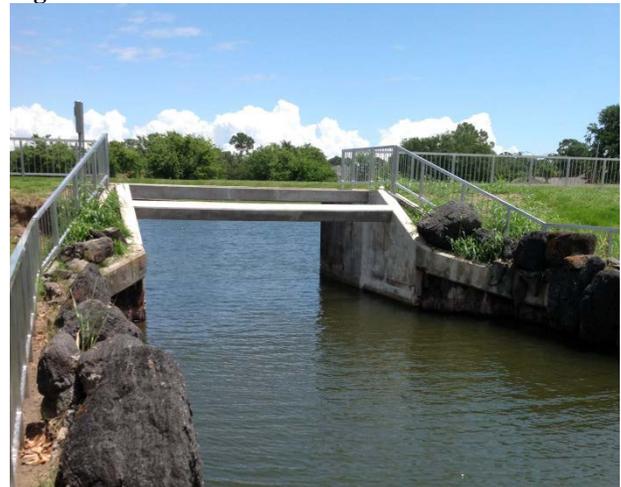
Figure 1b. Structure Removed

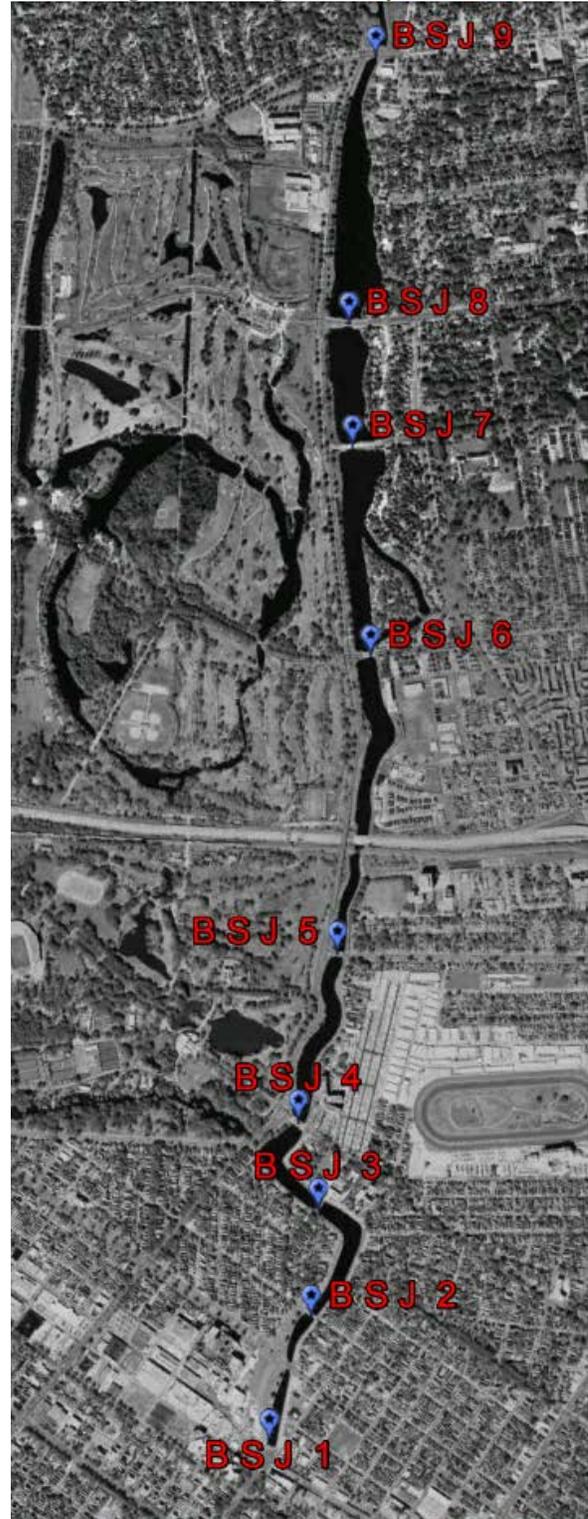
Figure 2. Bayou St. John Water Quality Monitoring Sites. (image courtesy of USGS)

The nine locations along the entire length of Bayou St. John (Figure 2) were sampled bi-weekly beginning in July 2012 and continuing to present. Each site was chosen based on proximity to land features and access for monitors to collect readings at the surface and mid-point of the water column. Data collected in the field was then entered into an Excel database with analytics being conducted by both students and staff. The statistical program JMP was utilized for statistical analyses.

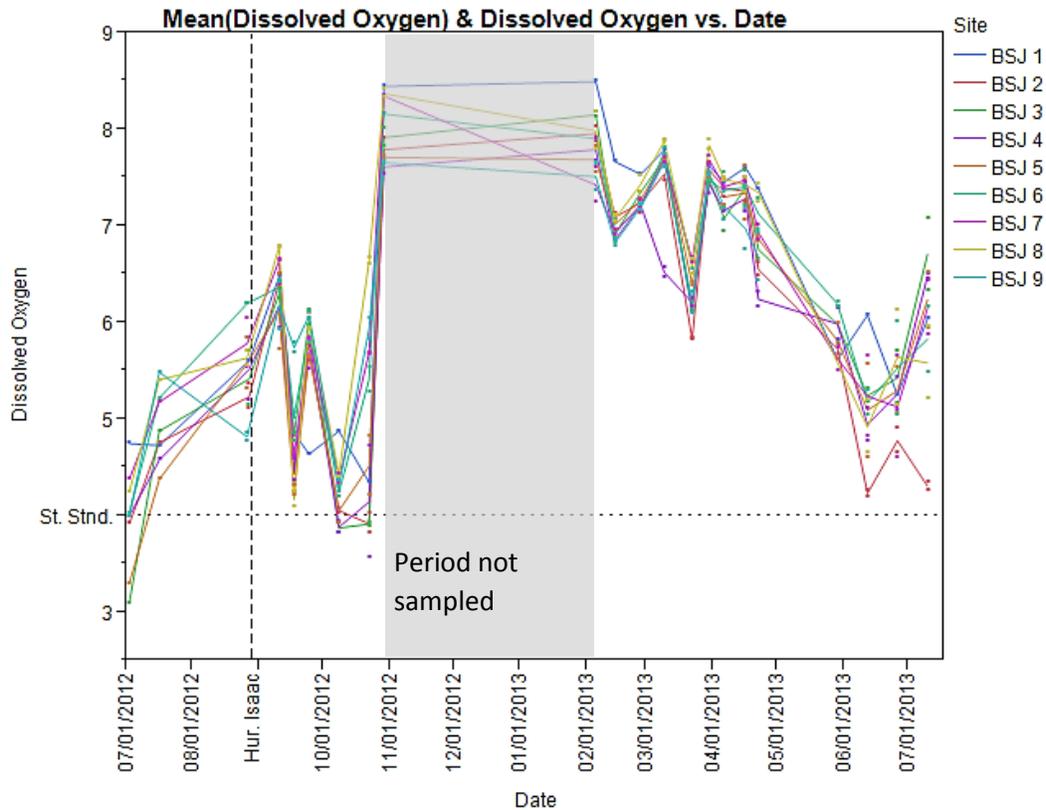
Figure 4. Mean dissolved oxygen for Bayou St. John sites by date

Dissolved oxygen also fluctuated and rose in response to temporary gate openings during the test phase and remained elevated in January when the control structure was removed. Since January of 2013, dissolved oxygen levels have fluctuated and showed the expected decrease with corresponding rising temperatures in spring but remained above the state standard of 4 mg/l.
